Aries

CSP microstrip socket
Cycling Test
DC Measurement Results

Gert Hohenwarter

2/7/2005

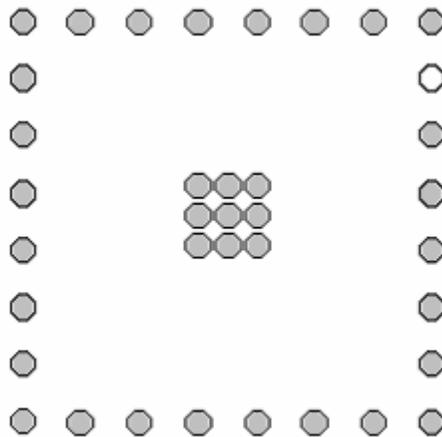
Figure 1 CSP socket test arrangement

To avoid any cross-effects from dc testing on RF characterizations, a different contact is used for this program. As shown in Fig. 1, the contact under test is on the side of the socket, typically the second from the top. The same contact will be used for all dc measurements, shown here in white.

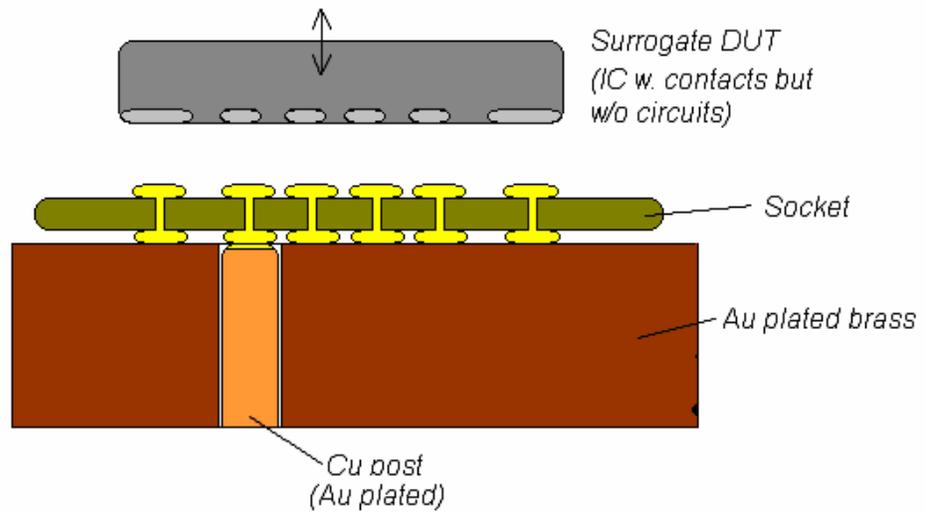
Figure 3 Cycling setup for socket testing

Two different types of cycling apparatus were used. Depending on the socket type either a mechanical cyler with parallel plates moving by a small amount or a solenoid based cyler were used. Displacement was typically established such that the surrogate test devices bottom out in the socket.

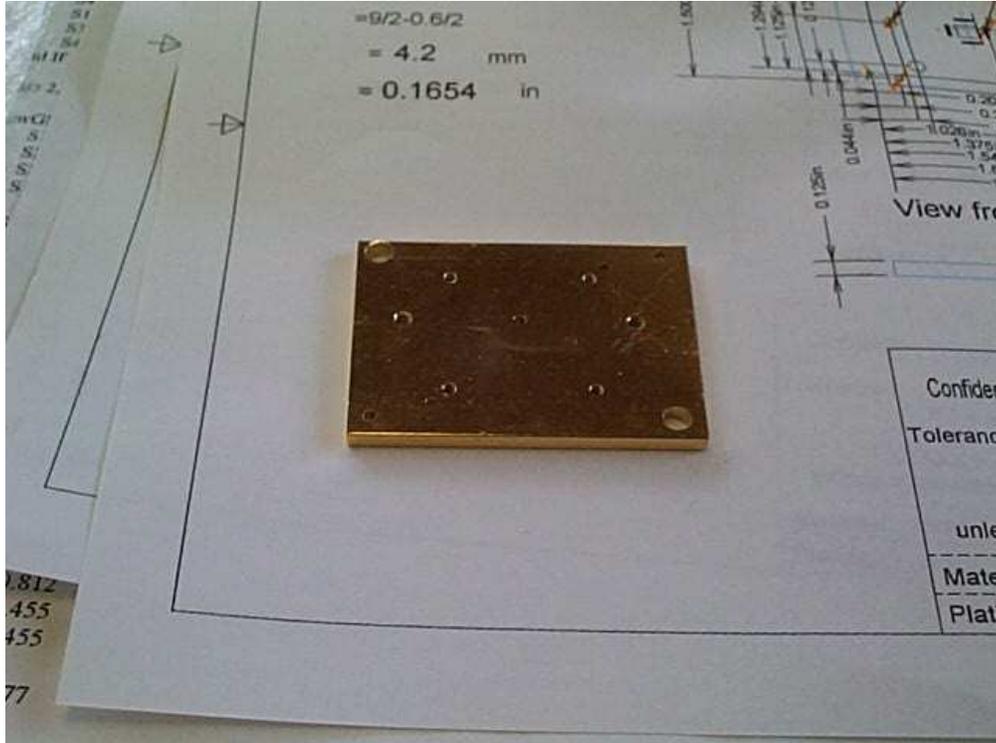
Figure 4 CSP socket mounting plate example

The socket is mounted on a brass plate similar to the one shown in Fig. 2. This plate has a small hole through which a probe is inserted for the dc testing. Since this plate is also used for mechanical cycling with surrogate devices, the probe bore is plugged with a metal plug during this procedure.

Au over Ni plating was applied to the surfaces of the brass plate. Material type and thickness specifications were identical to those used for PCBs.

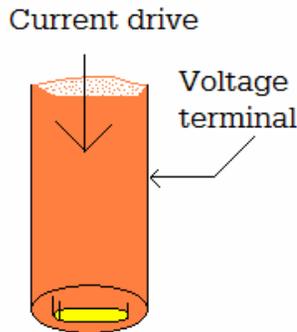
Figure 5 Current drive probe

The current/voltage probe consists of a copper post with suitably shaped surface. This surface is Ni and Au plated. The post has two connections, thus allowing for a four terminal measurement with very low residual resistance (about 1 milliOhm).

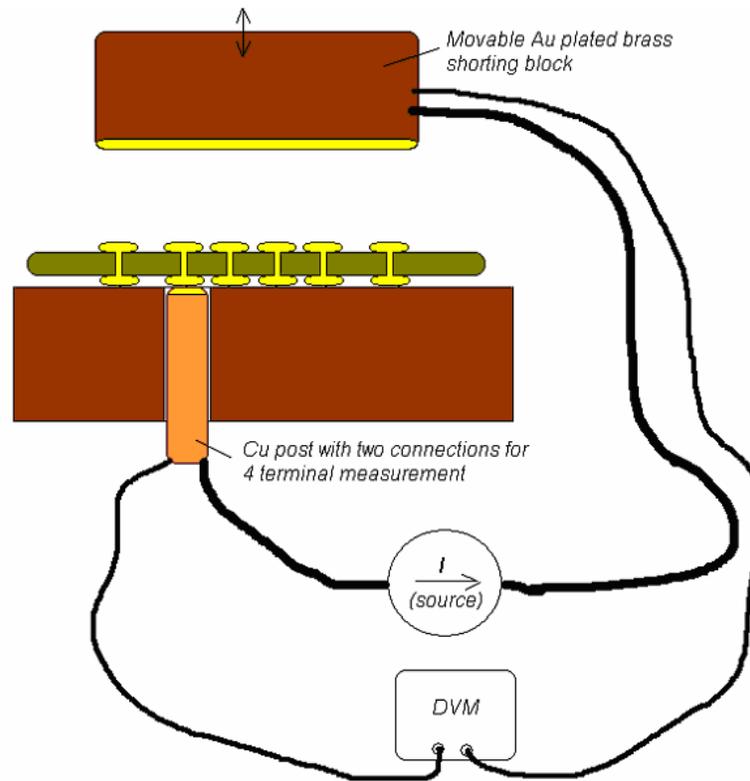
Figure 6 Test setup for 4 terminal (Kelvin) measurements

For current handling tests, all contacts are grounded except for one. The socket is then placed into the test setup. A brass plunger shaped like an actual test IC is pressed against the contacts on the DUT side of the socket. Au over Ni plating was applied to the surface of the plunger. A four terminal (Kelvin) measurement setup is used that included a computer controlled current source capable of delivering 10 A. The voltage developed across the contact is recorded at separate terminals with an HP3456A digital voltmeter. Once the data are available, they are processed to reveal the resistance and power dissipation as a function of drive current.

The same setup is used for contact resistance measurements. In this case, connections are made only to an HP3456A DMM. It is operated in 4 wire mode for this measurement. A precision linear potentiometer serves as a distance transducer. Its resistance is recorded by a second HP3456A DMM.

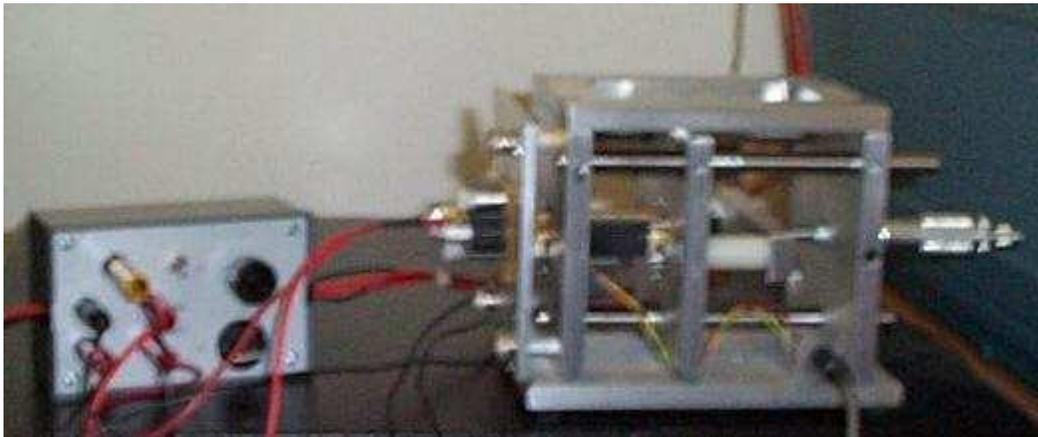
Figure 7 Test stand

The socket with its plate is mounted in a test stand with XYZ adjustment capability (Fig. 7).

This setup has a micrometer screw that allows repeatable adjustments in the Z direction. Also included is a transducer that converts Z position to an electrical signal for the data acquisition.

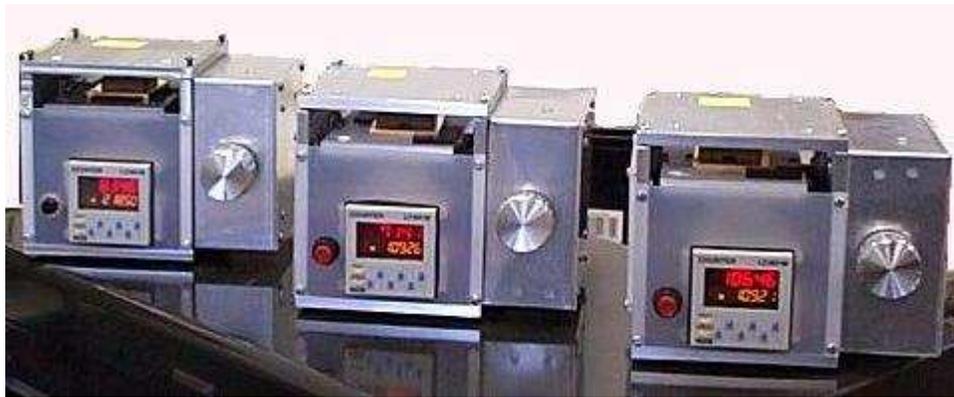
Figure 8 Parallel plate cyclers

For the parallel plate setup force limiting was accomplished by inserting a thin hard rubber sheet between the DUT and the moving plates. Parameters were selected such that under maximum deflection and normal cycling conditions the surrogate device

touches the bottom of the socket. Where necessary, pressure sensitive paper was used to verify this condition. Maximum speed of this setup was 3 cycles per second.

When a solenoid based cycler was used, force limiting was via solenoid drive current when necessary. Force measurements were performed with a pressure indicating paper that is capable of determining the magnitude of the applied pressure and hence the force. This method is necessary because of the dynamic situation that exists with the solenoid plunger / surrogate chip holder assembly entering the DUT with some speed and hence contributing to the maximum force. Maximum operating speed was 10 cycles per second.

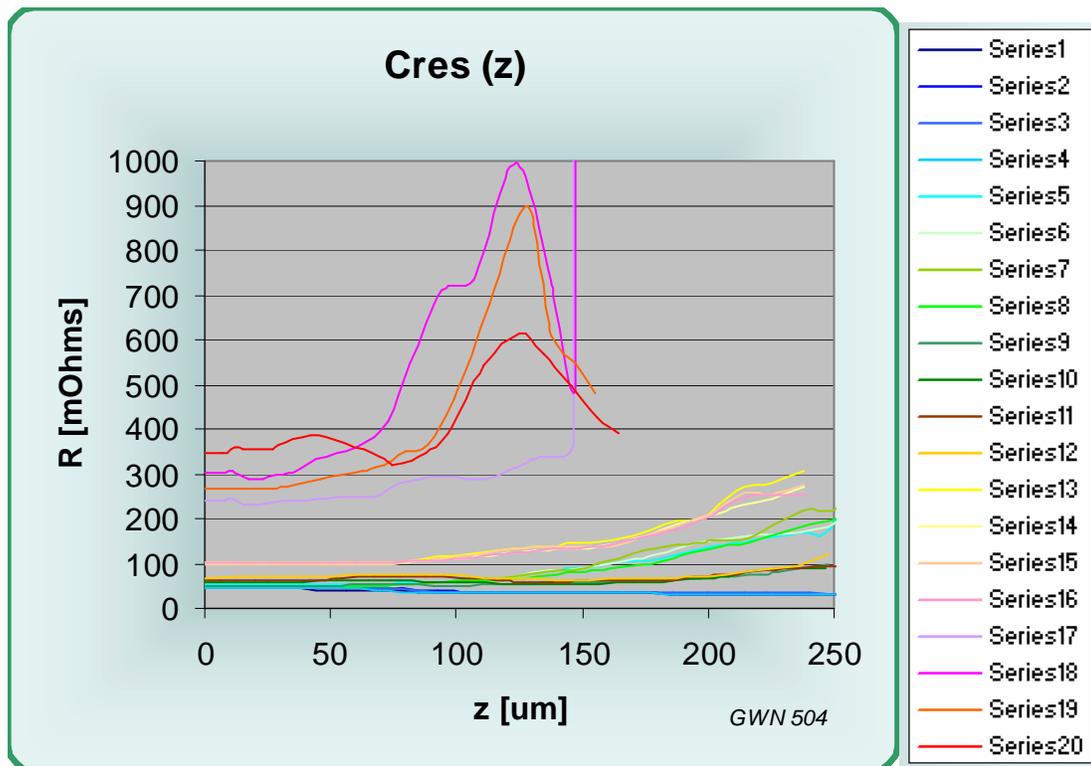
Figure 9 Contact resistance as a function of displacement

For this graph, the value $z=0$ represents the maximum compression in operation, i.e. with the DUT fully inserted. The results are corrected with the functional dependence of resistance as a function of displacement as obtained via regression during the cycle

0 test. As cycle numbers increase (=> series#), so does the overall resistance. It should be kept in mind here, that the resistance indicated includes contact resistance to the probe (=loadboard), the DUT, and the contact itself. For complex contact assemblies, this may be a significant contribution to the overall value.

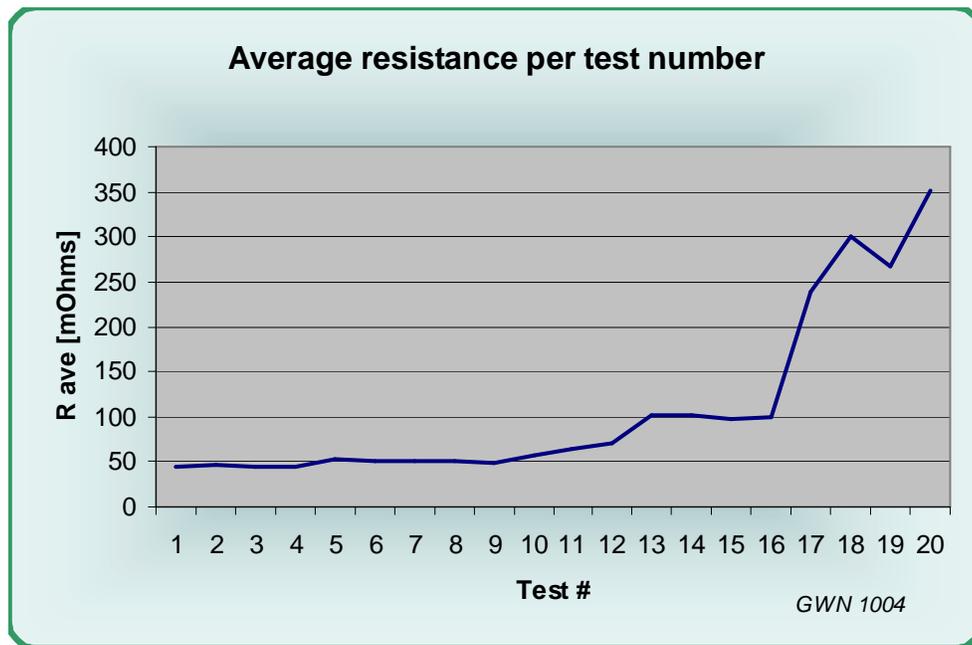
Figure 10 Contact resistance as a function of test number

As a measure of change throughout the cycles, the average resistance for the last 5 data points before the plunger reaches full insertion are plotted as a function of cycle number:

There is some resistance increase with increasing cycle numbers. It should be kept in mind, that the socket under test undergoes a number of matings/dematings with the test plates and probes. This may affect the backside contact of the socket and therefore the results shown.

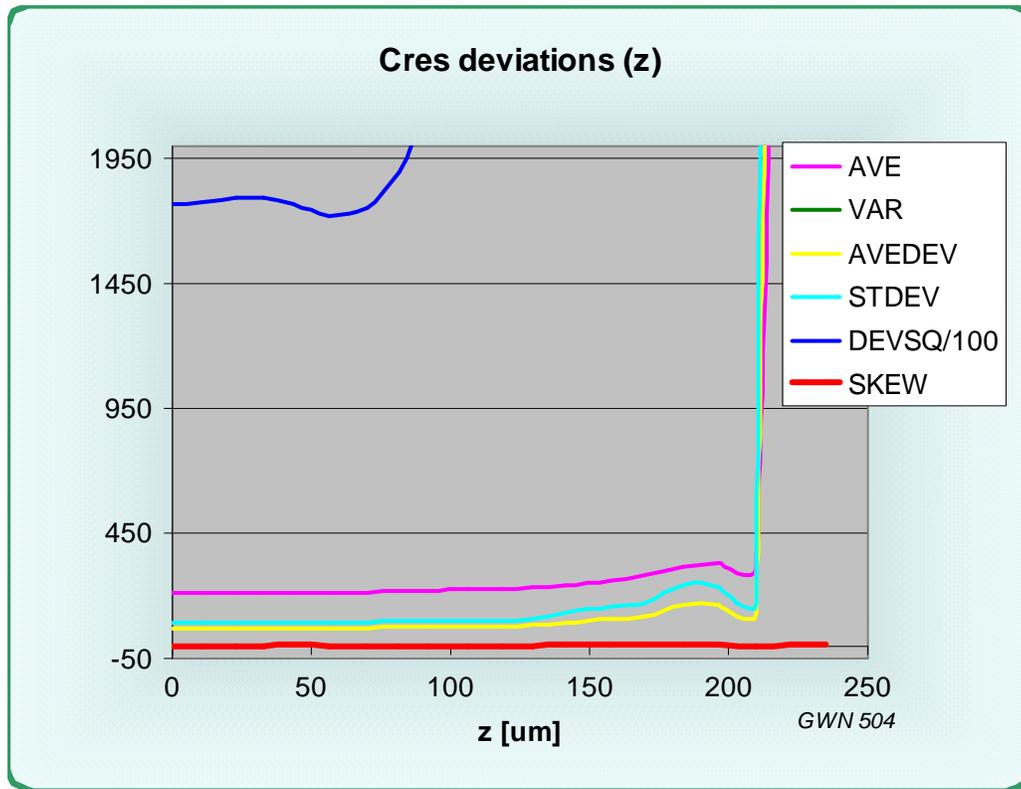
Figure 11 Statistics as a function of displacement

Also offered as a measure of contact performance are the deviations of the resistance as a function of displacement (plunger position, see graph below). Not

surprisingly, average and variability increase when less displacement (force) is applied by the plunger.

The dataset used for the statistical function is the recorded resistance at a particular displacement for the cycles from 1-20. Data are then displayed for each displacement from minimum to maximum. The following definitions are used (from MS Excel):

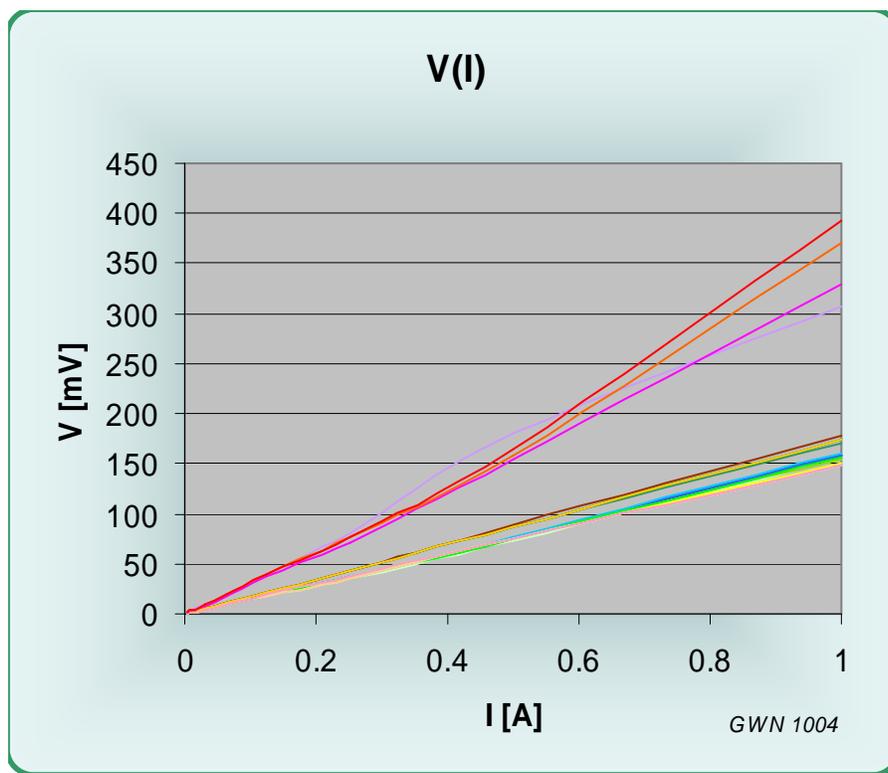
Figure 12 Voltage and resistance as a function of drive current

When measuring the current – voltage relationship for the CSP microstrip socket, the following responses were obtained (the color coding is identical to the previous graph):

There are no anomalies in this response. At one million cycles, resistance has increased. Damage to the contact under maximum rated drive current is not observed.

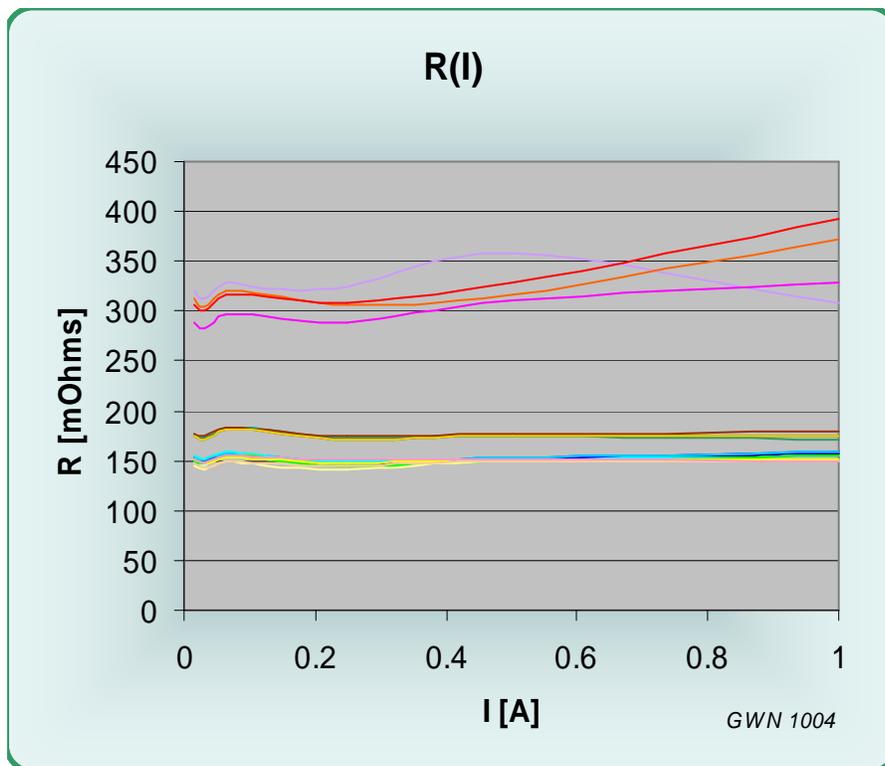
Figure 13 Resistance as a function of drive current

From the above graph it is possible to extract the resistance value at the corresponding drive current. Because of the absence of the strip under the socket and the resulting drive from the contact end, the current level was limited to 1A instead of the rated 4A to prevent damage. Values here are NOT corrected for the absence of a strip under the socket and therefore show a higher value than in the Cres measurement above. In reality the resistance level will be lower than shown in the following graphs. Therefore, this measurement is to be taken only as an indication of repeatability, NOT absolute resistance.

There are no significant changes of resistance with drive level. At current values below 20 mA the accuracy of the 10A current source is not sufficient to warrant extraction of resistance data.

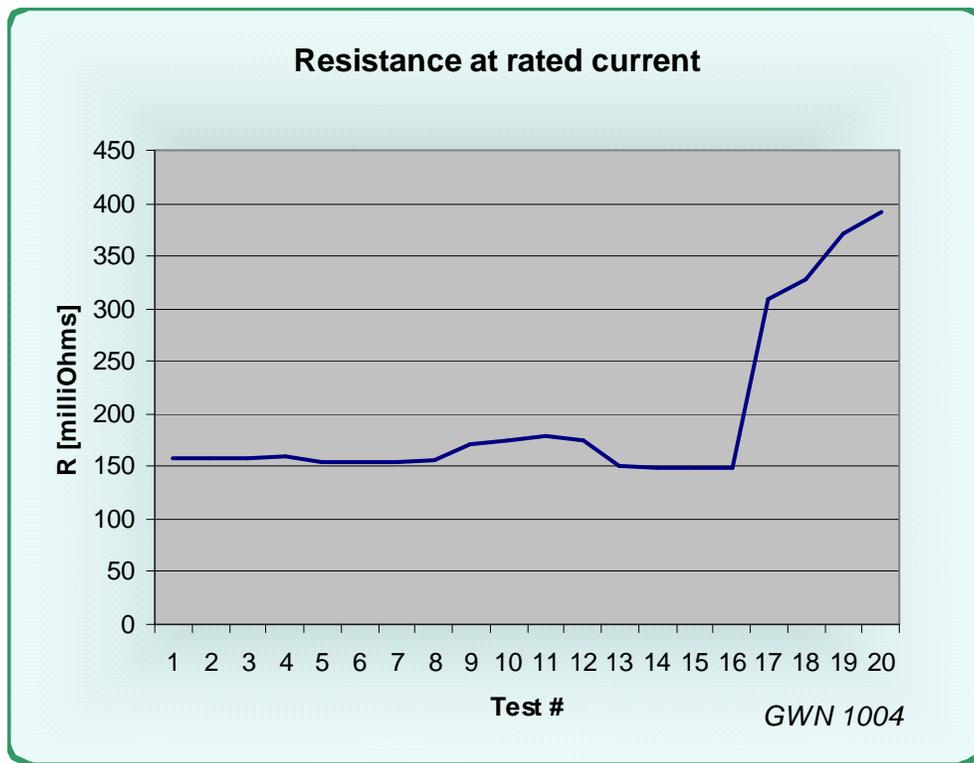
Figure 14 Resistance as a function of cycle # @ max. drive current

When plotting the resistance of the contact at 1A current as a function of cycle time, the following graph is obtained:

This graph shows no abnormal values. With increasing cycle number the overall resistance increases, but shows no irregularities. When comparing this to corresponding resistance values, it must be noted that the test numbers are not identical. In other words, these data are obtained after the socket has been tested in the resistance measurement sequence above. Hence, there will be no perfect correlation between these measurements and those obtained in the resistance measurement series.

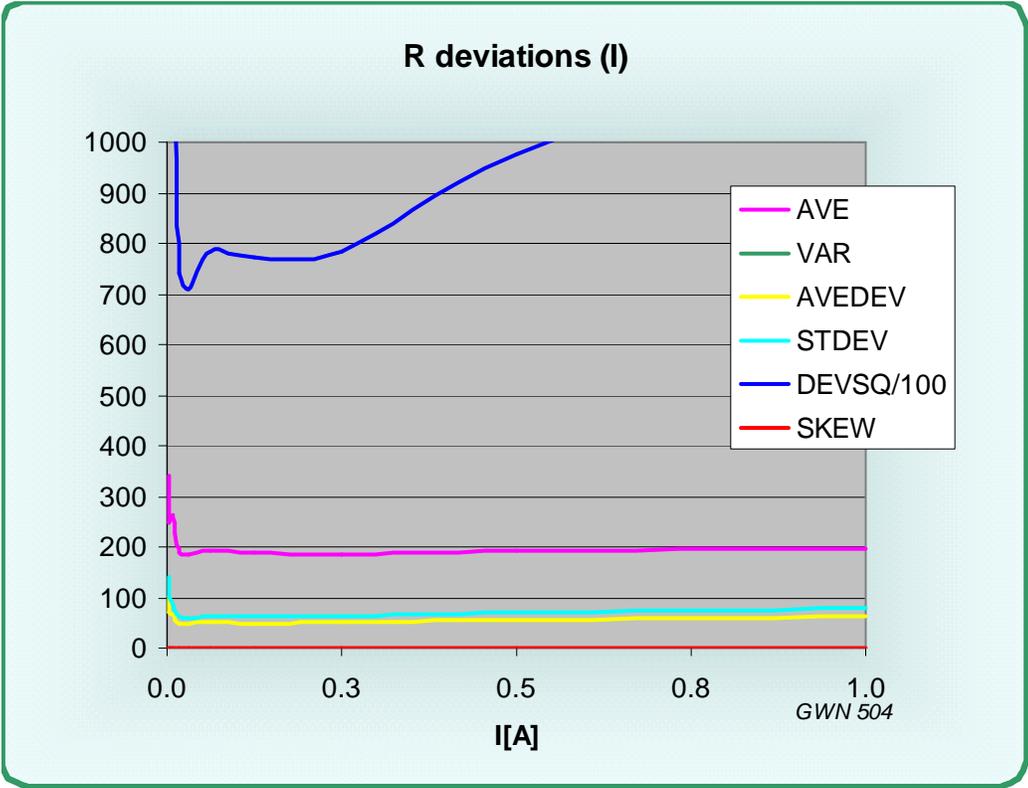
Figure 15 Deviations as a function of drive current

Statistical evaluation shows the following averages etc. as a function of drive current:

Definitions for the functions are given above. No abnormal values are present.

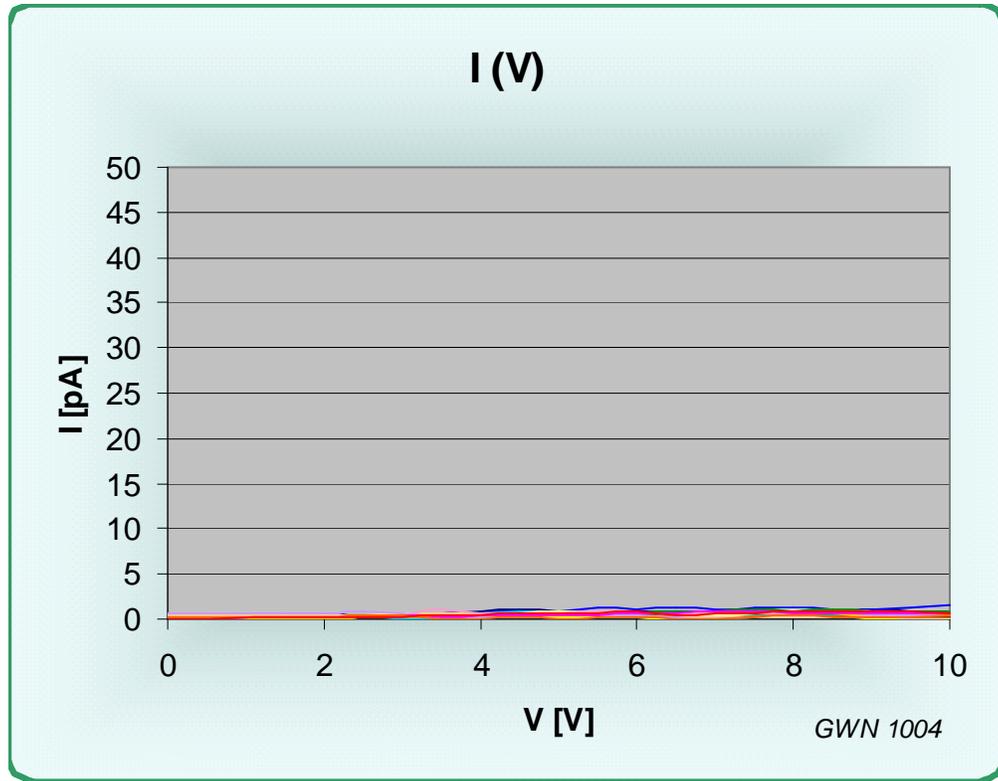
Figure 16 Leakage current as a function of drive voltage

To find any changes in the insulating performance socket materials and to identify any adverse contributions from debris accumulation, the leakage current was measured as a function of excitation voltage between the probe and all other test pins (ground):

Leakage is very low and is near the system limits of a few pA.

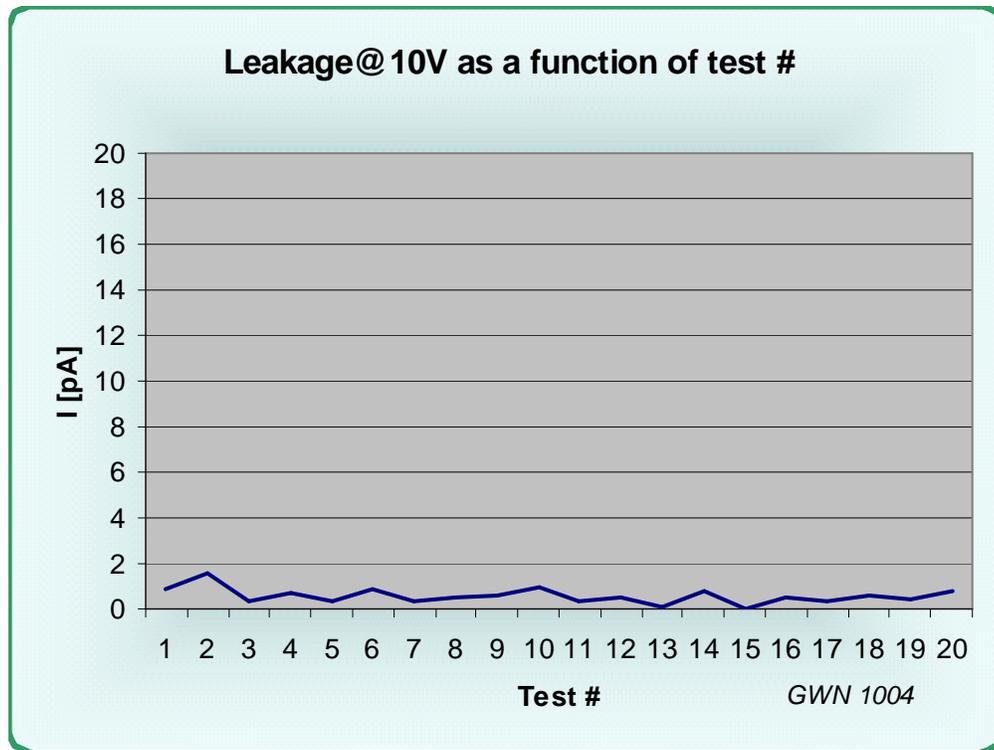
Figure 17 Leakage current @10V as a function of cycle #

Also of interest is the evolution of leakage with the number of test cycles. As such, the current observed at the 10 V excitation level is shown as a function of the test cycle number:

All values are within the system uncertainty. After the first four cycles an enhanced measurement technique was used. Values in the first four cycles are saddled with a greater system uncertainty, and hence may show larger leakage than actually present.

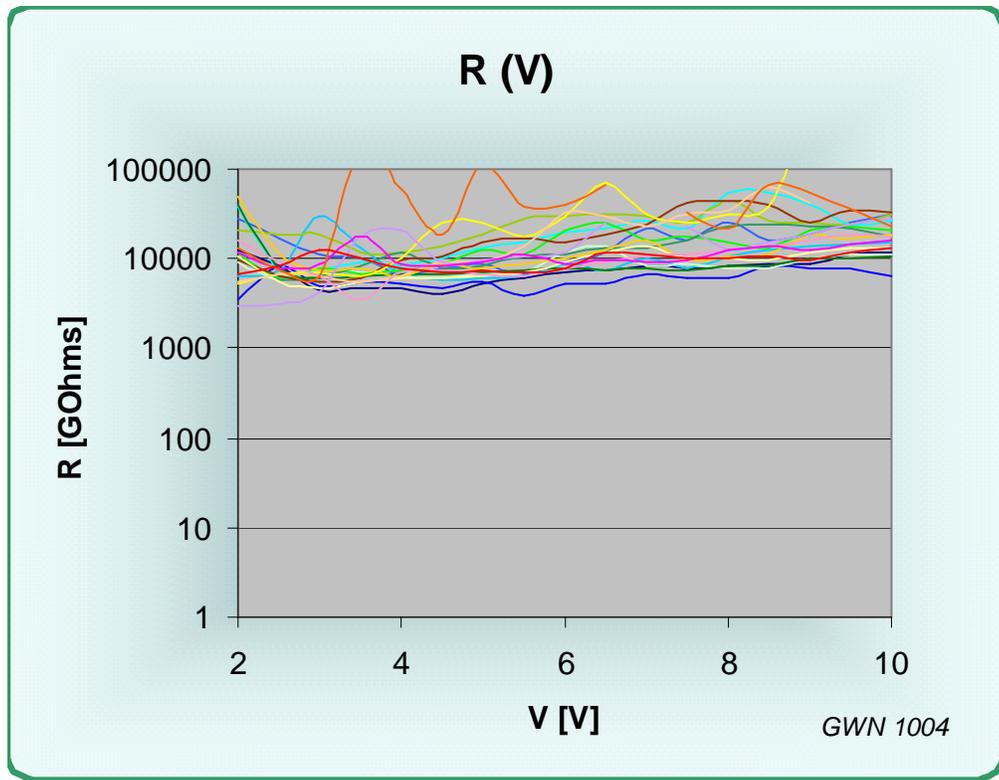
Figure 18 Leakage resistance as a function of drive voltage

When computing the corresponding resistance very large values result:

Total resistance values are very high and do not give any cause for concern. Values vary greatly, but of course all of them are at the very limit of the system capabilities.

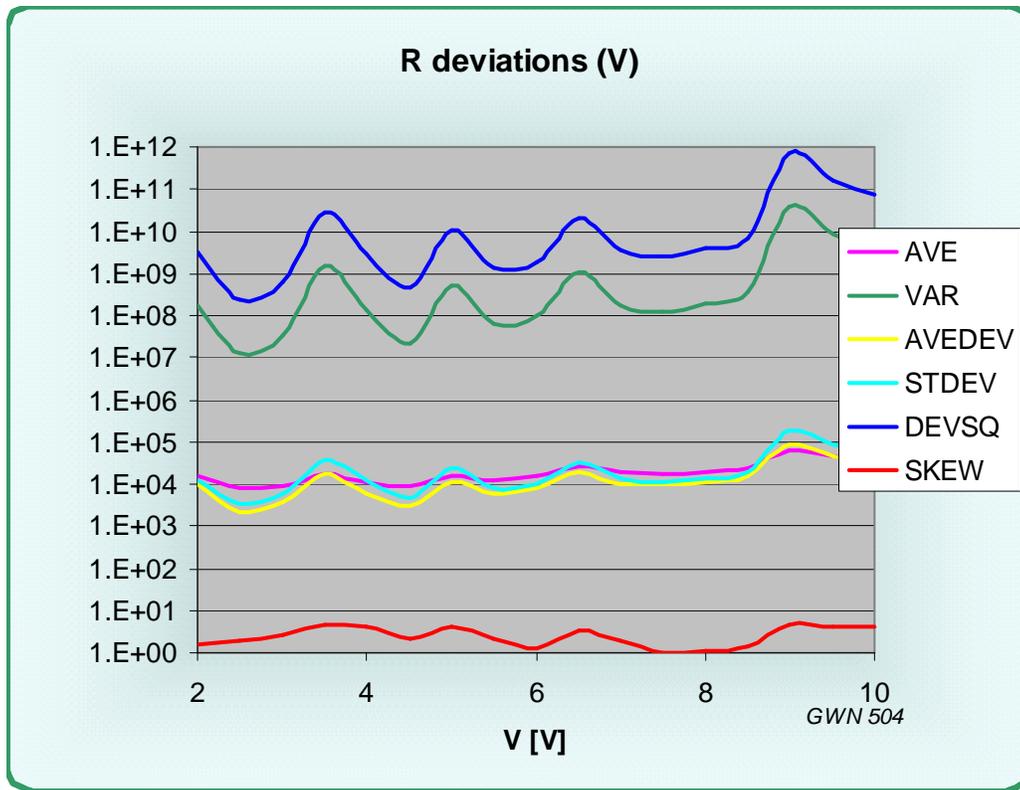
Figure 19 Leakage resistance variations as a function of voltage

Thus, it is somewhat difficult to consider deviations in an appropriate manner:

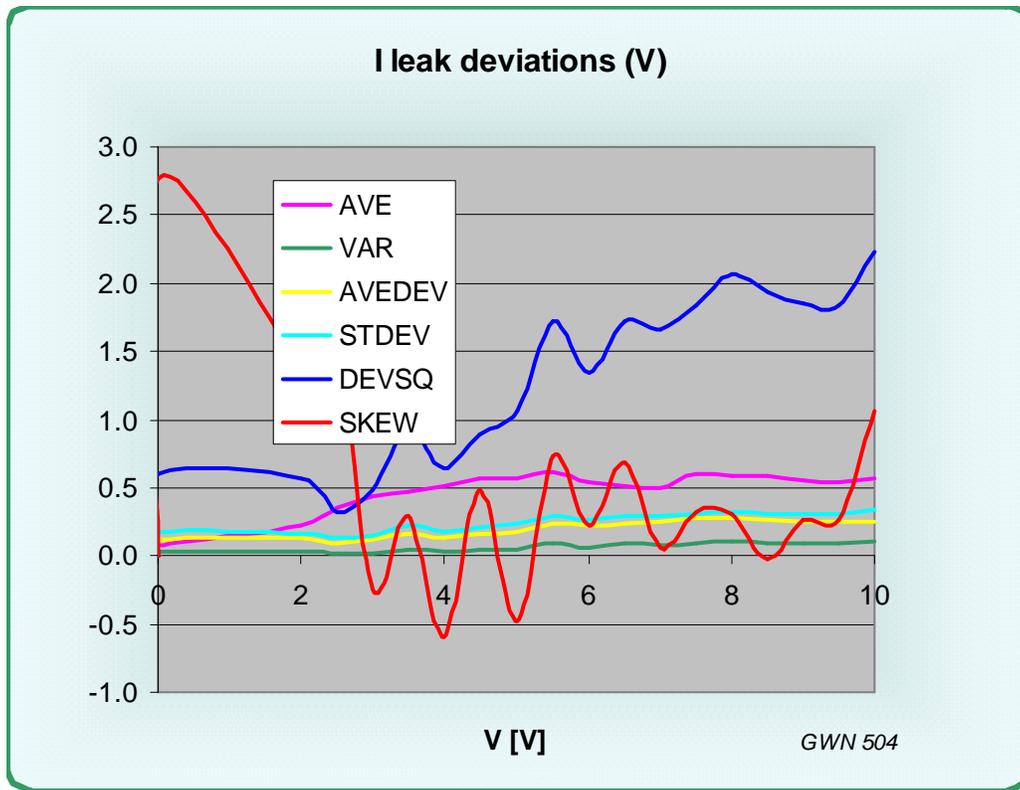
Figure 20 Leakage current variations as a function of voltage

Resistance variations will, of course be very large and it is thus perhaps better to consider leakage current statistics as shown below:

There are no anomalies in this response and no excess current is evident.

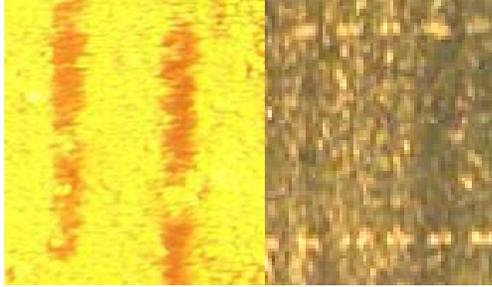
Also of interest were possible wear patterns caused by the contacts in the Au covered base plate. An image shows the area of that plate after the full complement of cycles. It should be noted that not only have the sockets been cycled to 1 million actuations, but also were mounted and demounted a large number of times on this plate.

Figure 22 Base plate shows slight signs of wear

A slightly visible wear pattern is discernible, likely caused by the socket strip contact pressing down on the plate during device insertion (left half of picture). Also noticeable are slight indentations at the rear end of the socket, where protrusions press into the base plate (right half of picture). Wear patterns in the surrogate device, of course, are very noticeable. This is not relevant to the socket assessment, however, since here surrogate devices were subjected to very large numbers of repeat insertions, a condition that does not reflect the operating environment found in the actual application.
